# Norfolk Southern Bay Window Caboose Versions

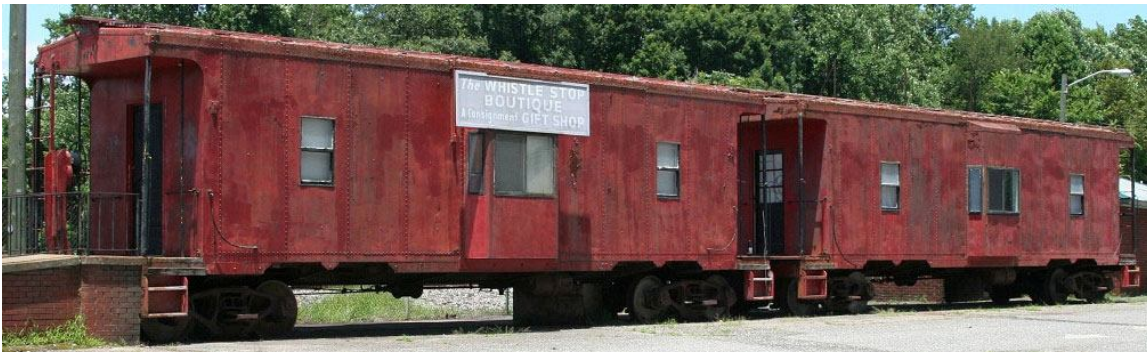
In July 2014 I made a Norfolk Southern photo trip (about 800 miles total). On Thursday morning I made it to Lincolnton NC and to Kings Mountain NC. I was able to get a lot of detail photos of NS-376 in Lincolnton, I also took some measurements of different parts. This caboose is in great condition.

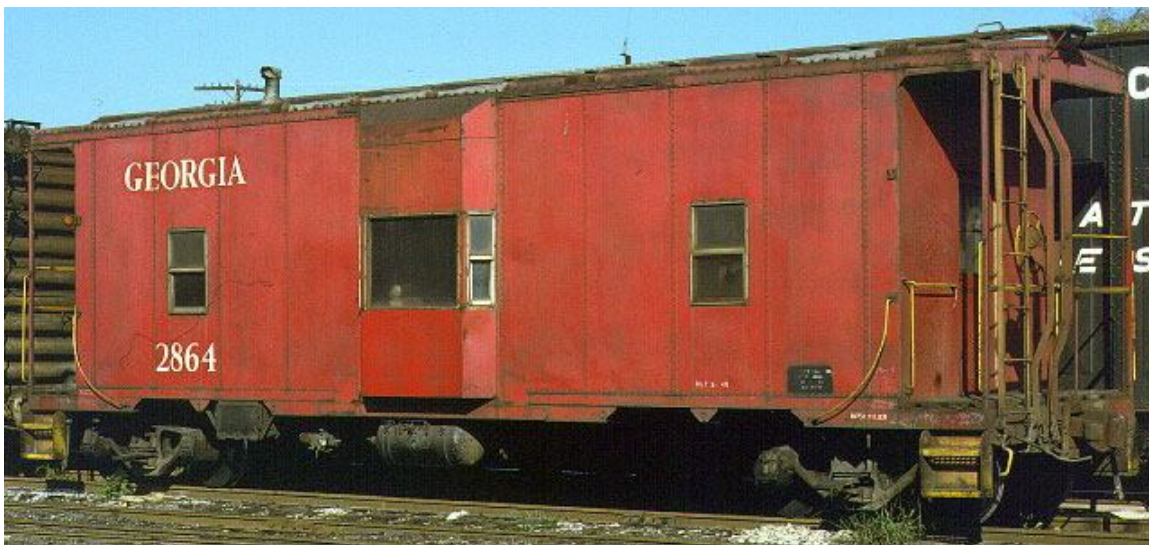
Friday morning I was in Duluth, GA looking at The Georgia Railroad bay window caboose #2866. Here again I was able to get a lot of detail photos to compare with the Norfolk Southern bay window caboose. This one has the full length brake wheel brace from the roof to the platform, longer curved grab irons, corner brace just like the last Norfolk Southern set.

Warren Calloway photos of Georgia 2864 (1967) and 2865 (1977) show these cabooses having the Viking Roof. The 2866 caboose in Duluth Georgia has a different style roof.

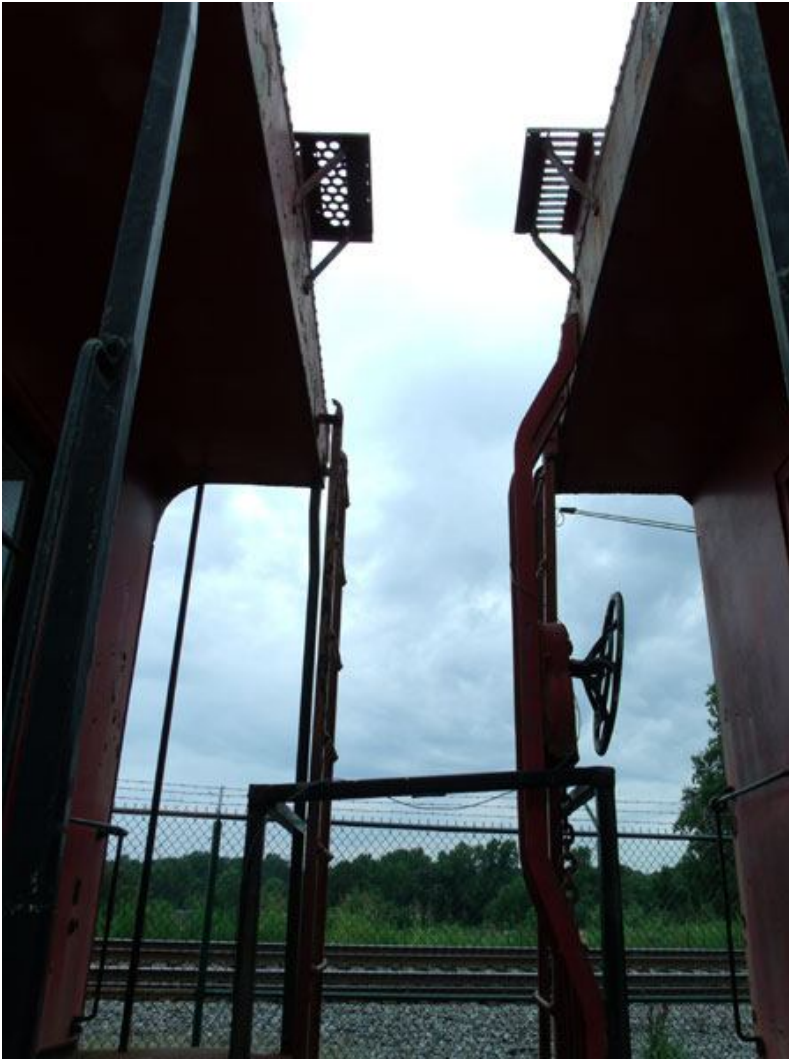
As we look up at the roof grid, there is a difference of the early version on the left and the late version on the right. Slotted holes on the left walk grid.

Now as we look down at the steps grids it looks almost like it is reversed. Slotted holes on the right steps grid.

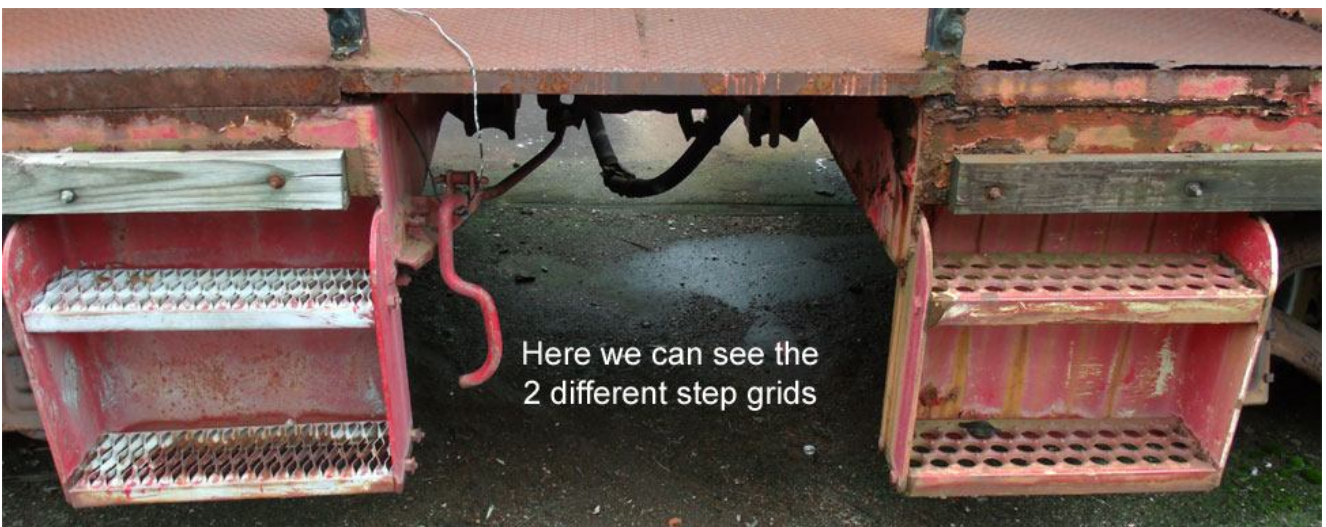
Here we can see the 2 different step grids

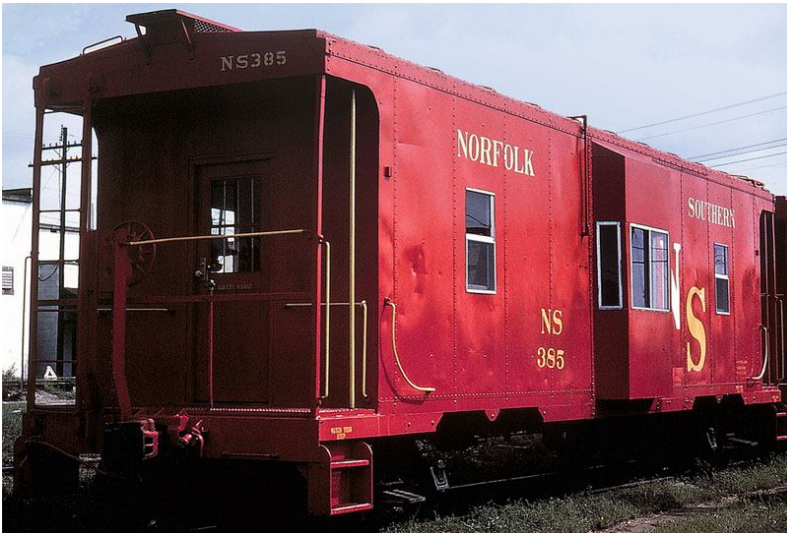
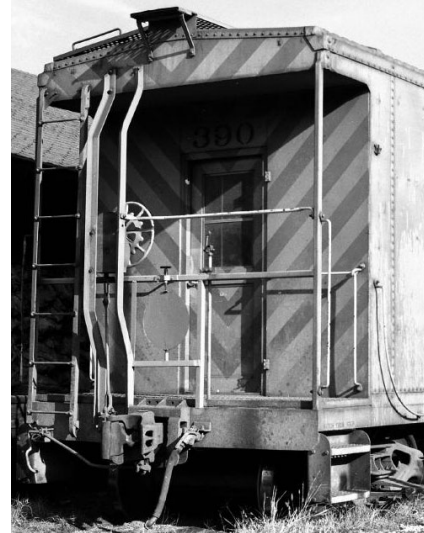
Norfolk Southern 385 and 390, Early and Late Version end view.

1. Short length brake wheel brace on the platform
2. Roof walk with round slot openings
3. Steps have diamond slot openings
4. Short curve grab irons
5. Corner brace curves to the inside of roof
6. Long pole grab iron at back wall from the roof to the platform

1. Full length brake wheel brace from the roof to the platform
2. Roof walk with long slot openings
3. Steps have round slot openings
4. Long curve grab irons
5. Corner brace mounted to outside of roof end.

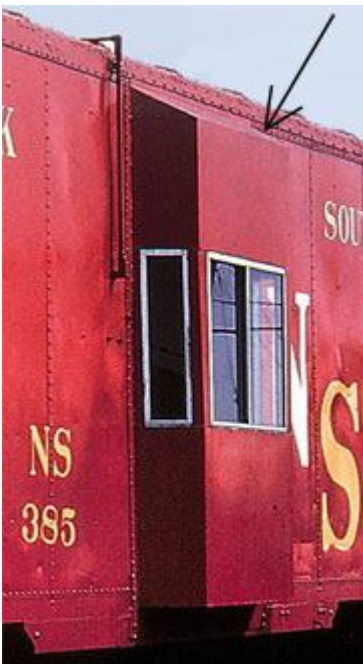
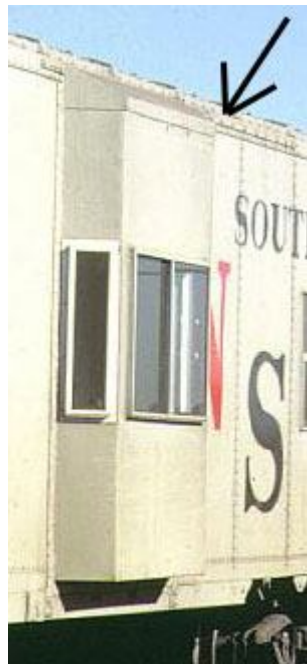
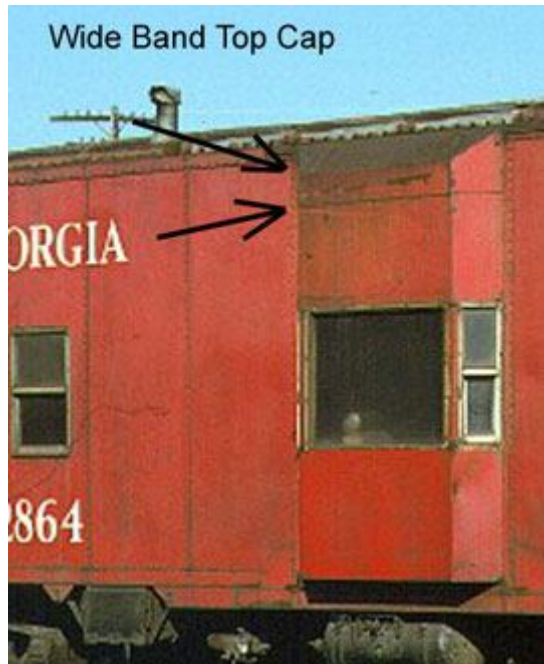
There is also another small difference at the top of the bay window box. Early version NS has no top cap band, late version NS has a small top cap band, the Georgia has a wide top cap band.

Notice the Georgia caboose large window and small sides that slide up and down. Only the large window on the NS slides open.
